Docket No. 217 – Development and Management Plan Inspection

Date: January 21, 2005

Location: Norwalk Substation Expansion

Location: Plumtree Substation Expansion , Bethel

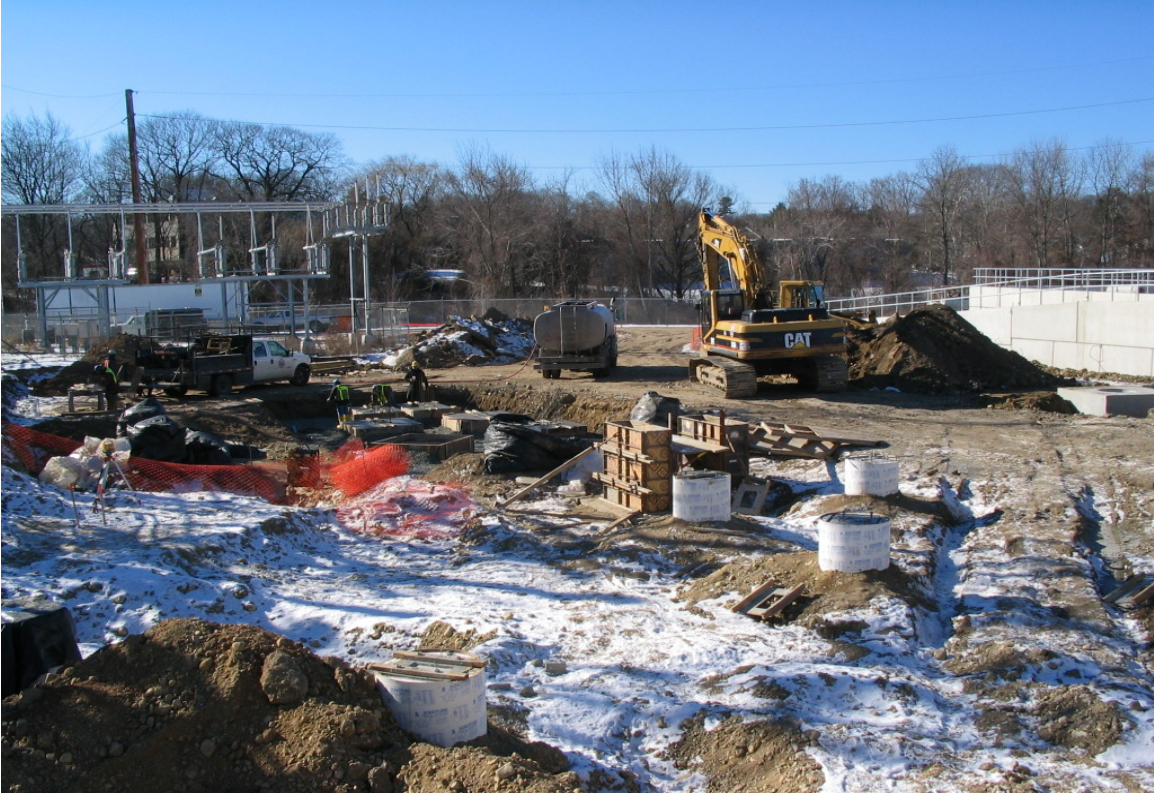
View of the footings and excavation for the work south of wall #3 for the continued expansion of equipment. All areas and small stockpiles remain contained. 1/21/05

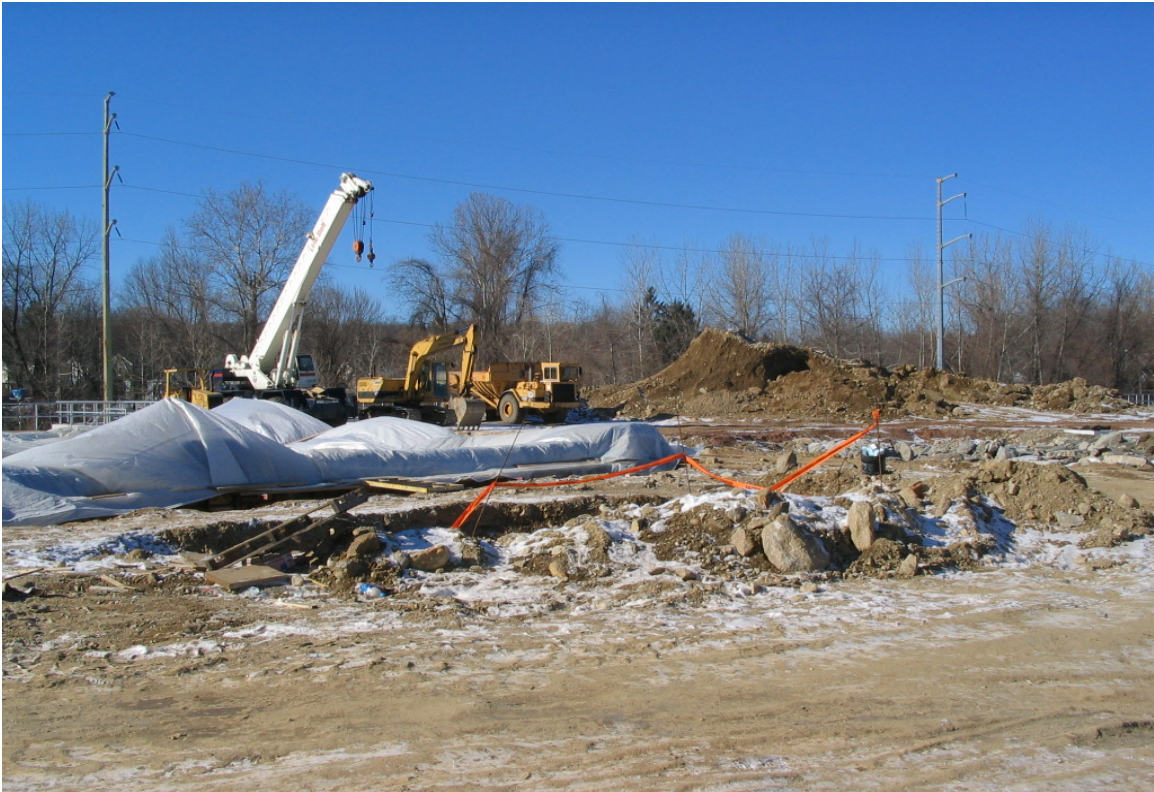
View of additional small areas of excavation adjacent to the continuing work on the GIS building forms. 1/21/05

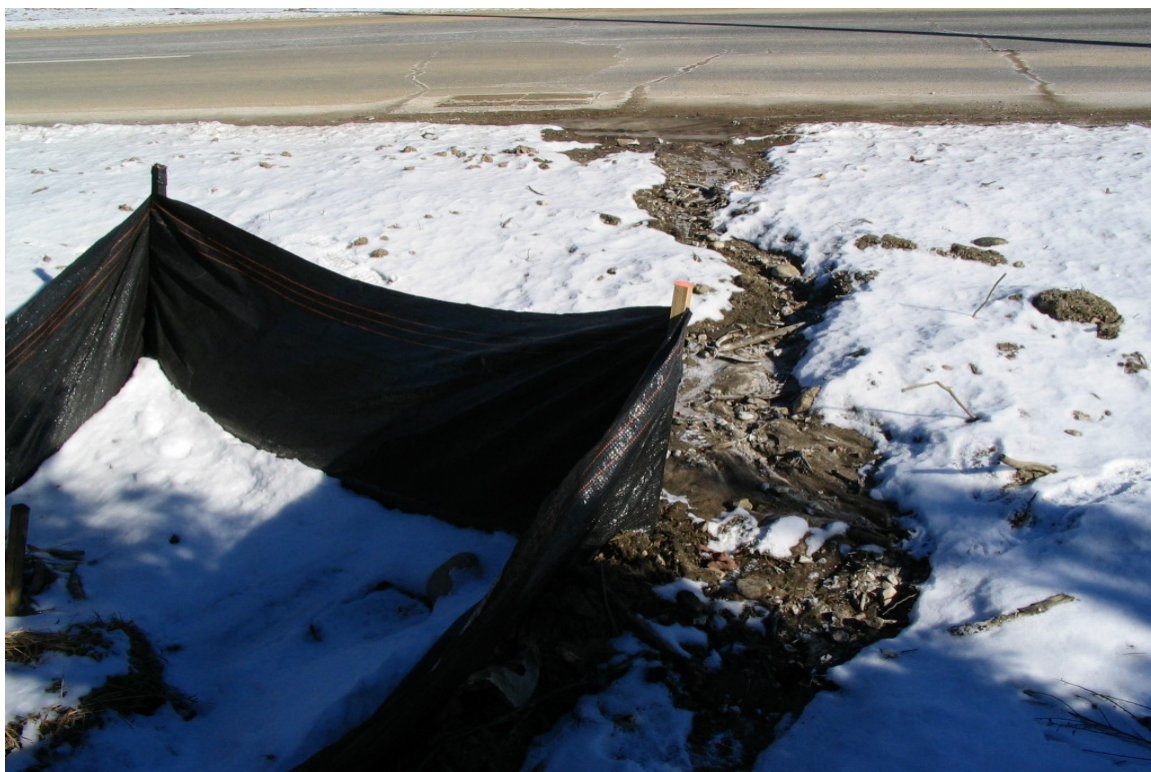
- The flared inlet near the Rt 7 ramp remains protected by haybale and silt fence controls. However, it does receive obvious stormwater flows and sediment has built up around the controls. 1/21/05	- Continue to monitor until stabilized as the surrounding area is still bare soil. Until vegetative cover establishes, the potential for sedimentation in this area remains 1/21/05

The inlet is well enclosed at this time but obvious on site and off site (roadway) stormwater does drain to this area. The surrounding bare soil will require vegetative cover with the growing season. 1/21/05

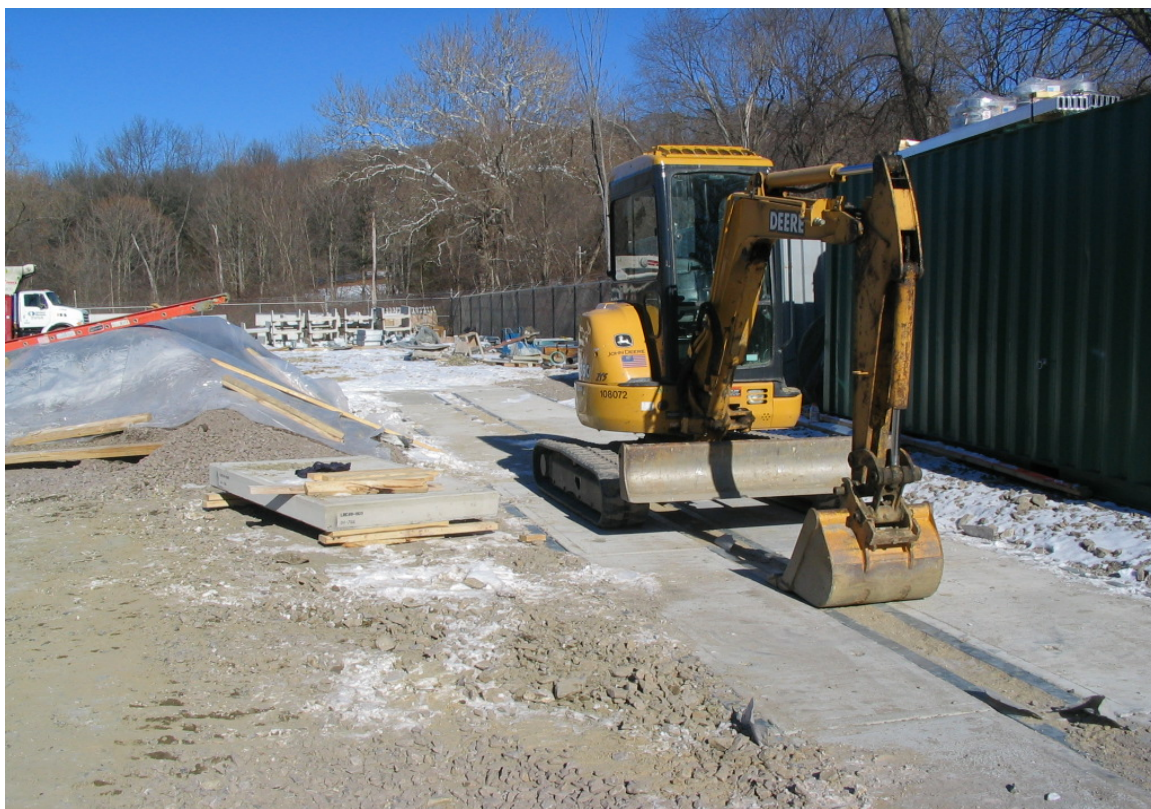
Plumtree Substation: Work continues on the cable trench near the trailers where concrete has been poured. 1/21/05

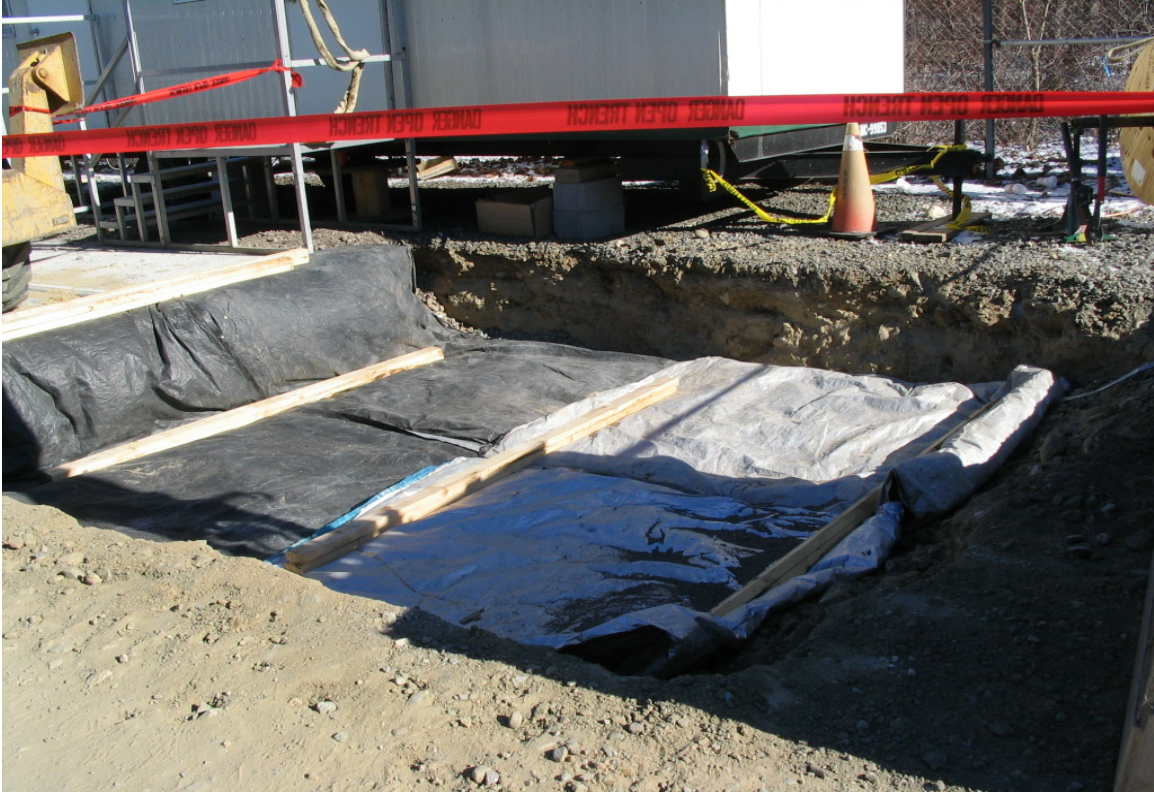
The trench excavation continues towards the gate to the yard. 1/21/05

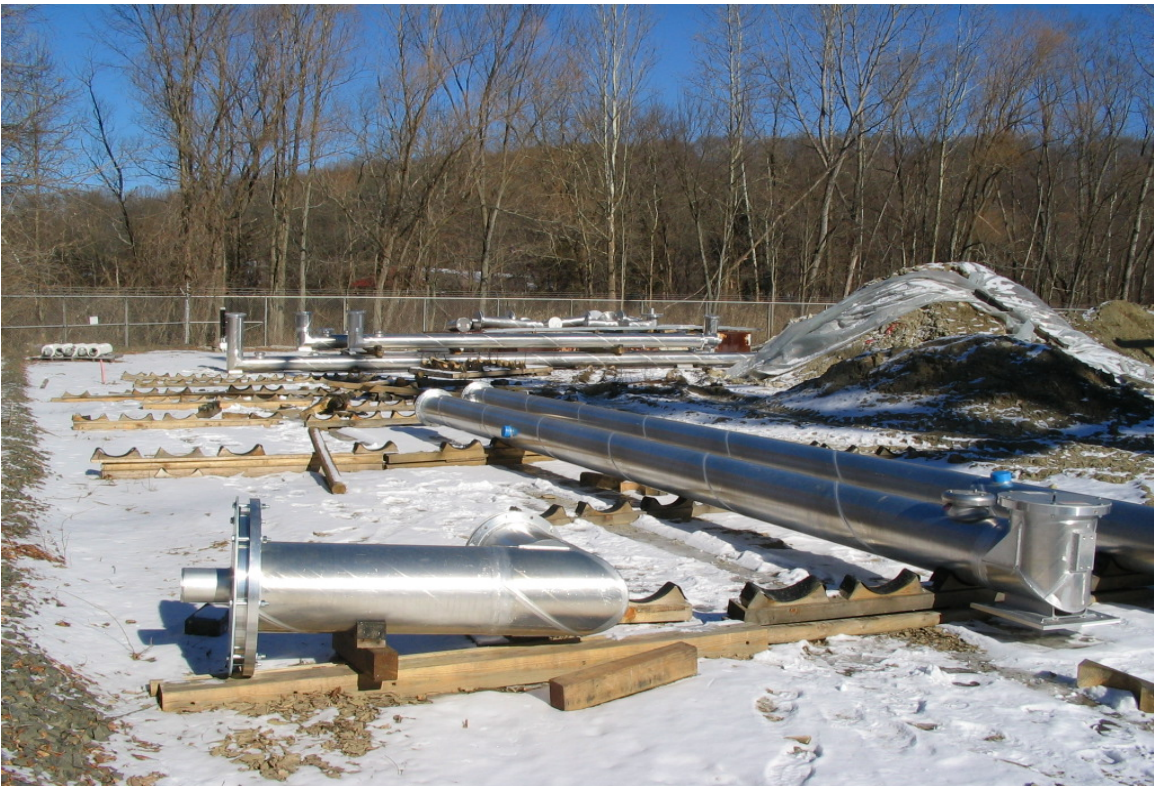
The site surface has frozen again and pooling water is not a problem at this time. 1/21/05
